Re: Fire Station #1 Restoration Study

RESTORATION STUDY
'HISTORIC' FIRE STATION NO. 1
Leawood, Kansas

RESTORATION STUDY 'HISTORIC' FIRE STATION NO. 1

LOCATION: 9609 Lee Boulevard, Leawood, Kansas

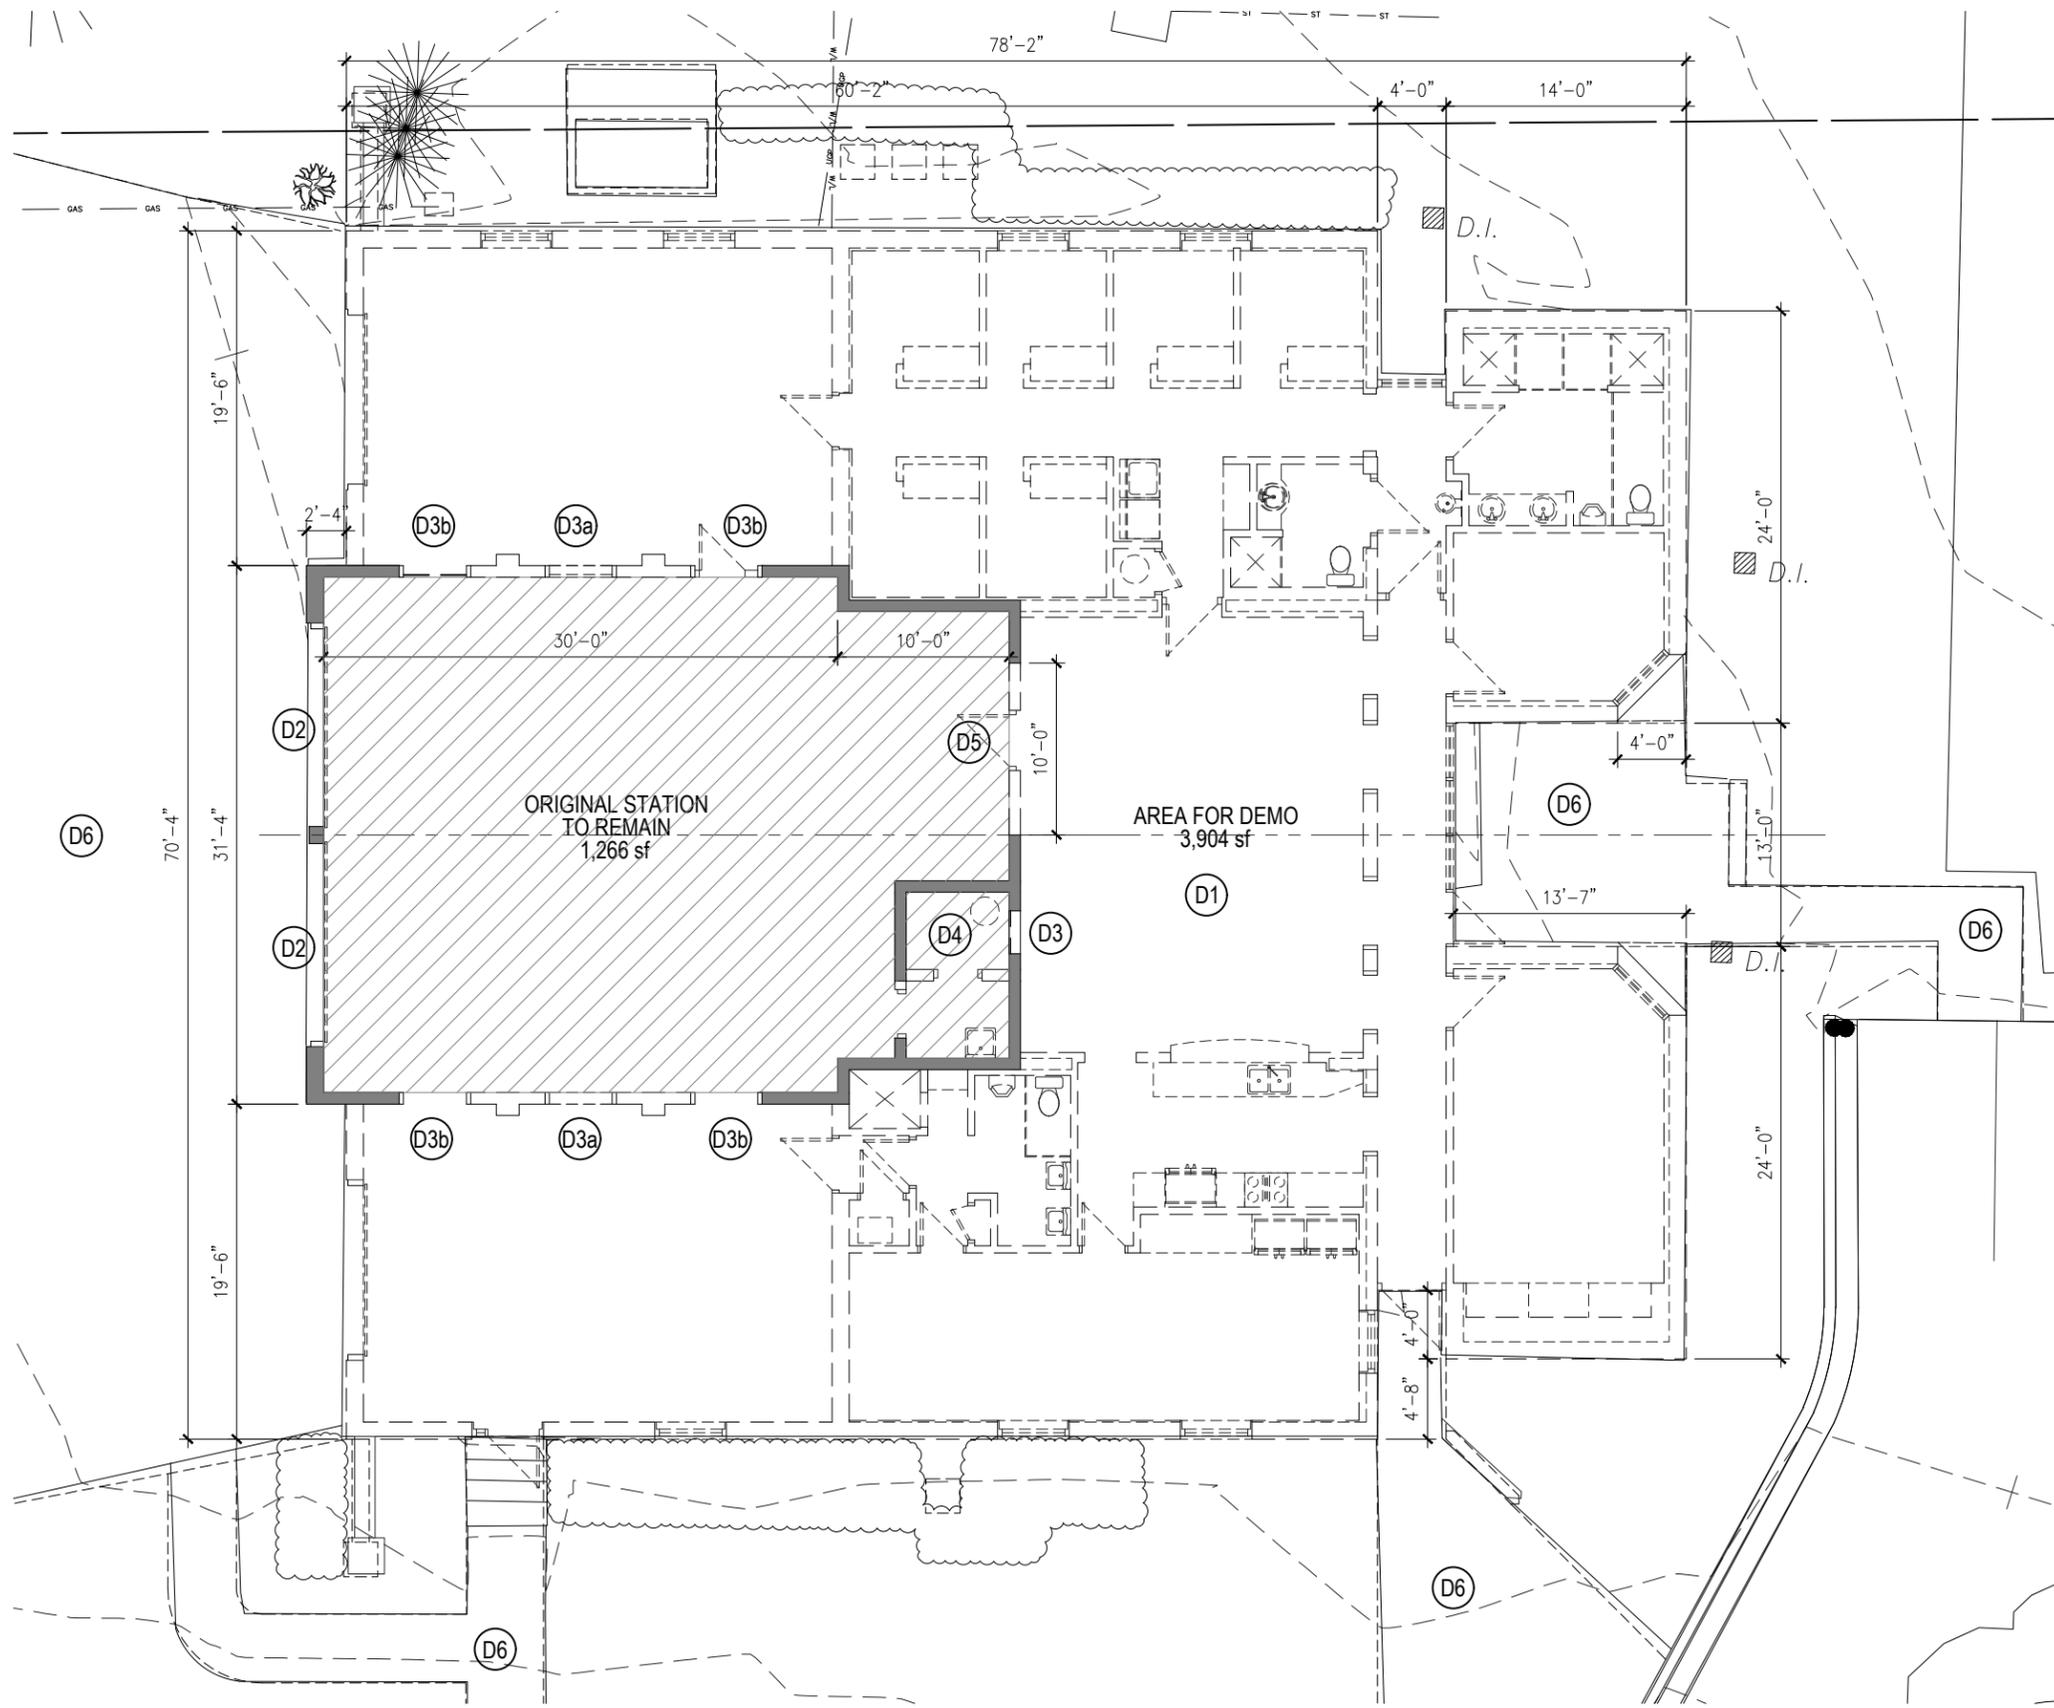
DEMO PLAN

DEMO KEY NOTES:

- D1 The initial historic station, denoted by the cross hatched area, is to remain. Demolish all additions surrounding the original structure.
- D2 Remove overhead doors and related components.
- D3a Option A:
Remove windows and doors. Remove two center portions of wall, install steel portal frame per Structural for support.
- D3b Option B:
Remove windows and doors in the walls of the original structure. Evaluate frames for reuse/repair, or need of replacement.
- D4 Remove interior wall in mechanical room. Remove plumbing fixtures and equipment.
- D5 Cut 10' wide opening in masonry wall. Provide steel lintel support per structural.
- D6 Remove front entry drive in it's entirety to Lee Boulevard, patio, and sidewalks adjacent to the building. back to the curbs. (drives and parking lot to

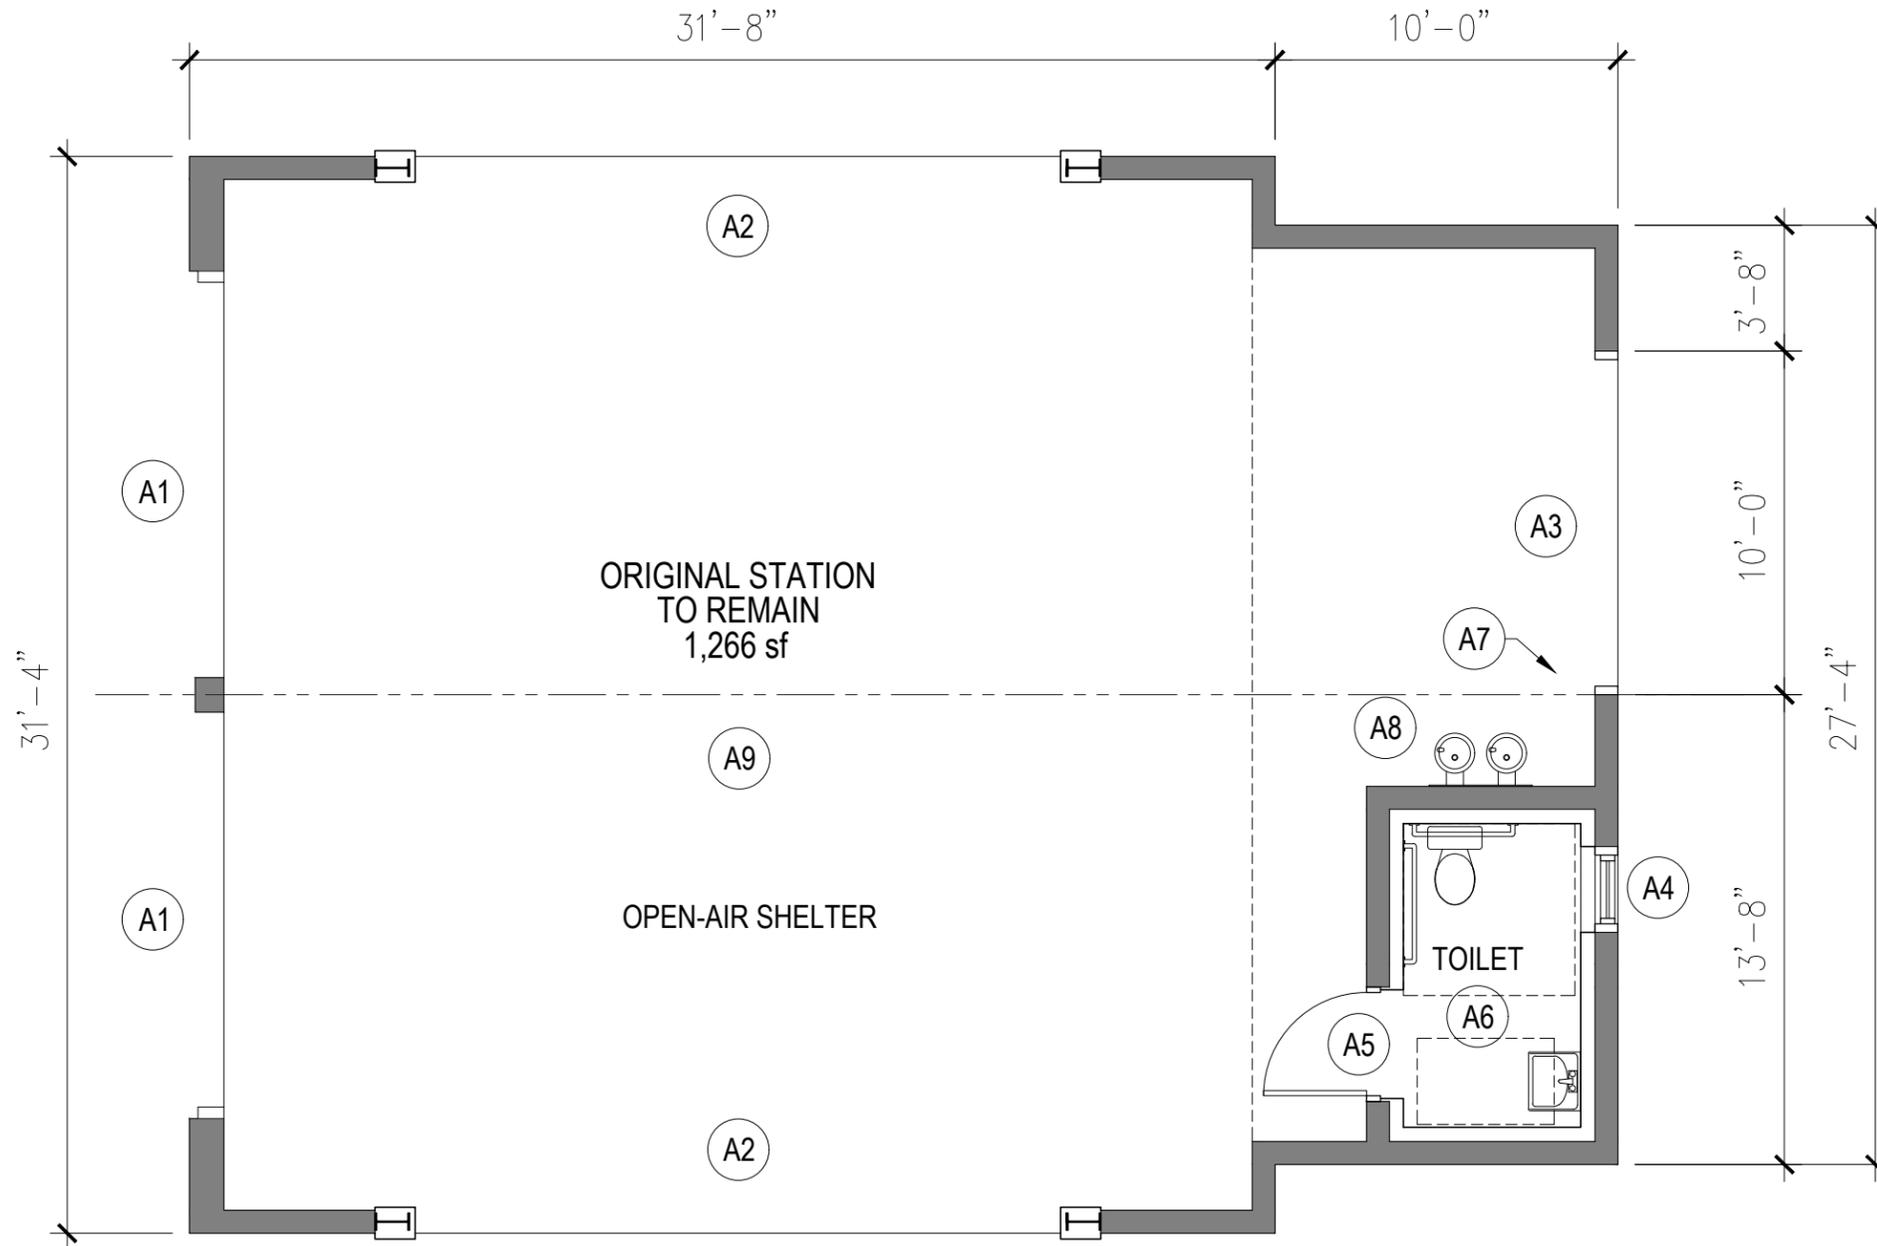
REMODEL PLAN

OPTION 'A' KEY NOTES:

- A1 Repair/paint overhead door frames. No doors provided, to remain open.
- A2 Install steel 'portal frame' for support of widened opening, per structural. Provide ornamental wood cladding. Patch floor slab.

- A3 Install wood frame surround to match historic profile in widened exterior opening. (no infill).
- A4 Install wood window frame with infill aluminum clad window with frosted glass at Toilet Room.

- A5 Cut opening wider in existing masonry wall for installation of Toilet Room door. Install painted hollow metal door and frame, with closer.
- A6 For Toilet Room, install furred out walls with insulation on exterior walls. Wall finish to be ceramic tile full height all walls. Install toilet fixtures, grab bars, toilet accessories. Repair ceiling joists and install new drywall ceiling. Provide access panel to attic space.

- A7 Patch access opening in lower ceiling, patch with wood plank to match adjacent.
- A8 Install new hi/lo drinking fountain.
- A9 Clean and refurbish interior finishes, including floor slab, brick/glazed tile walls, and wood ceilings.

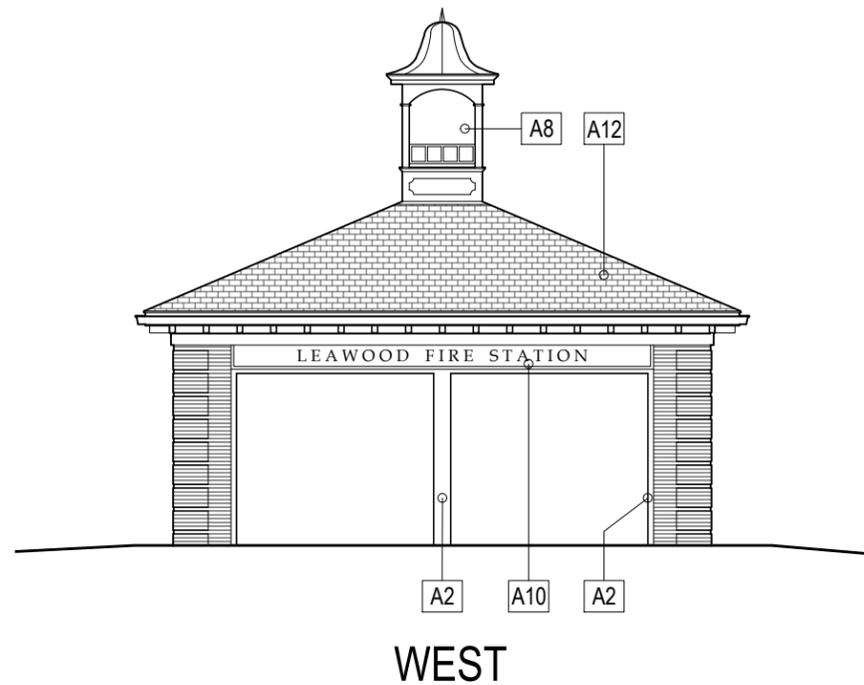
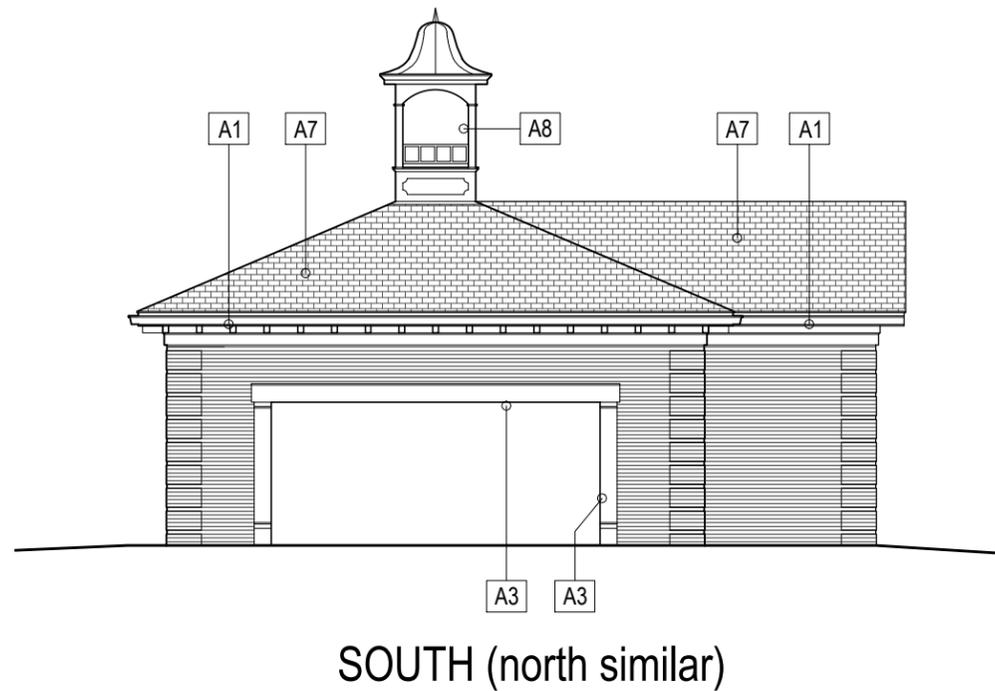
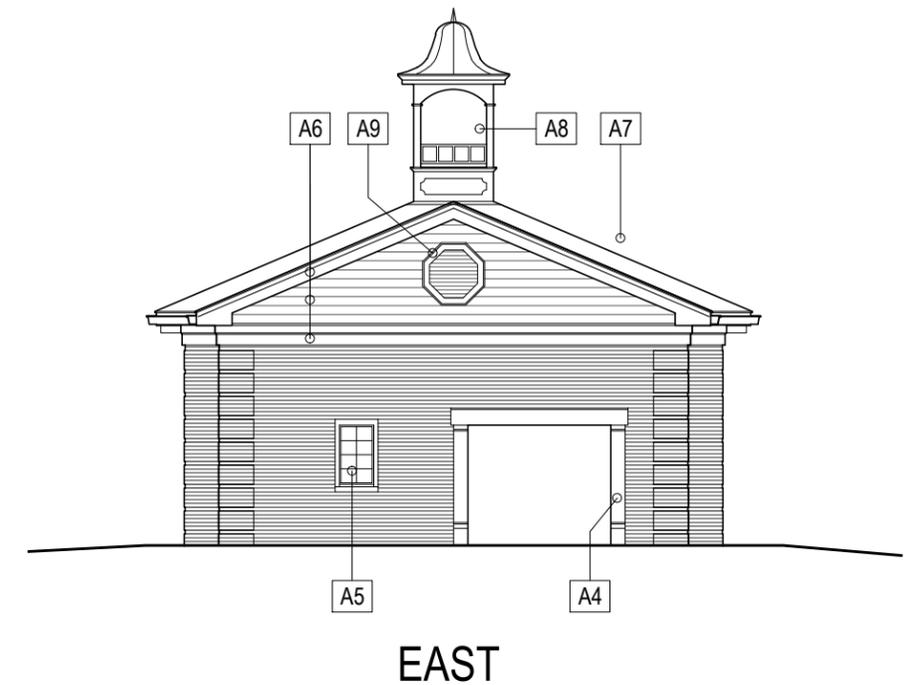
ELEVATIONS AT ORIGINAL BUILDING
October 4, 2108

ELEVATION KEY NOTES:

- A1 Rebuild roof fascias and soffits on north and south, with dentils and detailing to match existing west side.
- A2 Repair wood trim at overhead door openings, painted.

- A3 Install new steel portal frame to support widened opening on north and south. Provide ornamental wood cladding, painted.
- A4 Cut new widened masonry opening on east. Provide new steel lintel. Install new painted wood trim. (no doors or windows installed).

- A5 Install new window and jamb trim at opening in new toilet room (with frost glass).
- A6 Install new wood cornice mouldings and painted 'hardie board' lap siding in newly exposed pediment area of end gable. Repair existing substrate of gable and infill existing openings for new siding. Install eave overhangs.

- A7 Install new synthetic slate-tile look roof shingles, on new ice/water shield barrier. Assume patch and repair of existing wood decking.
- A8 Refurbish cupola; repairs and paint. Remove 'siren' component.

- A9 Install octagonal attic vent.
- A10 Repair or replace signage.

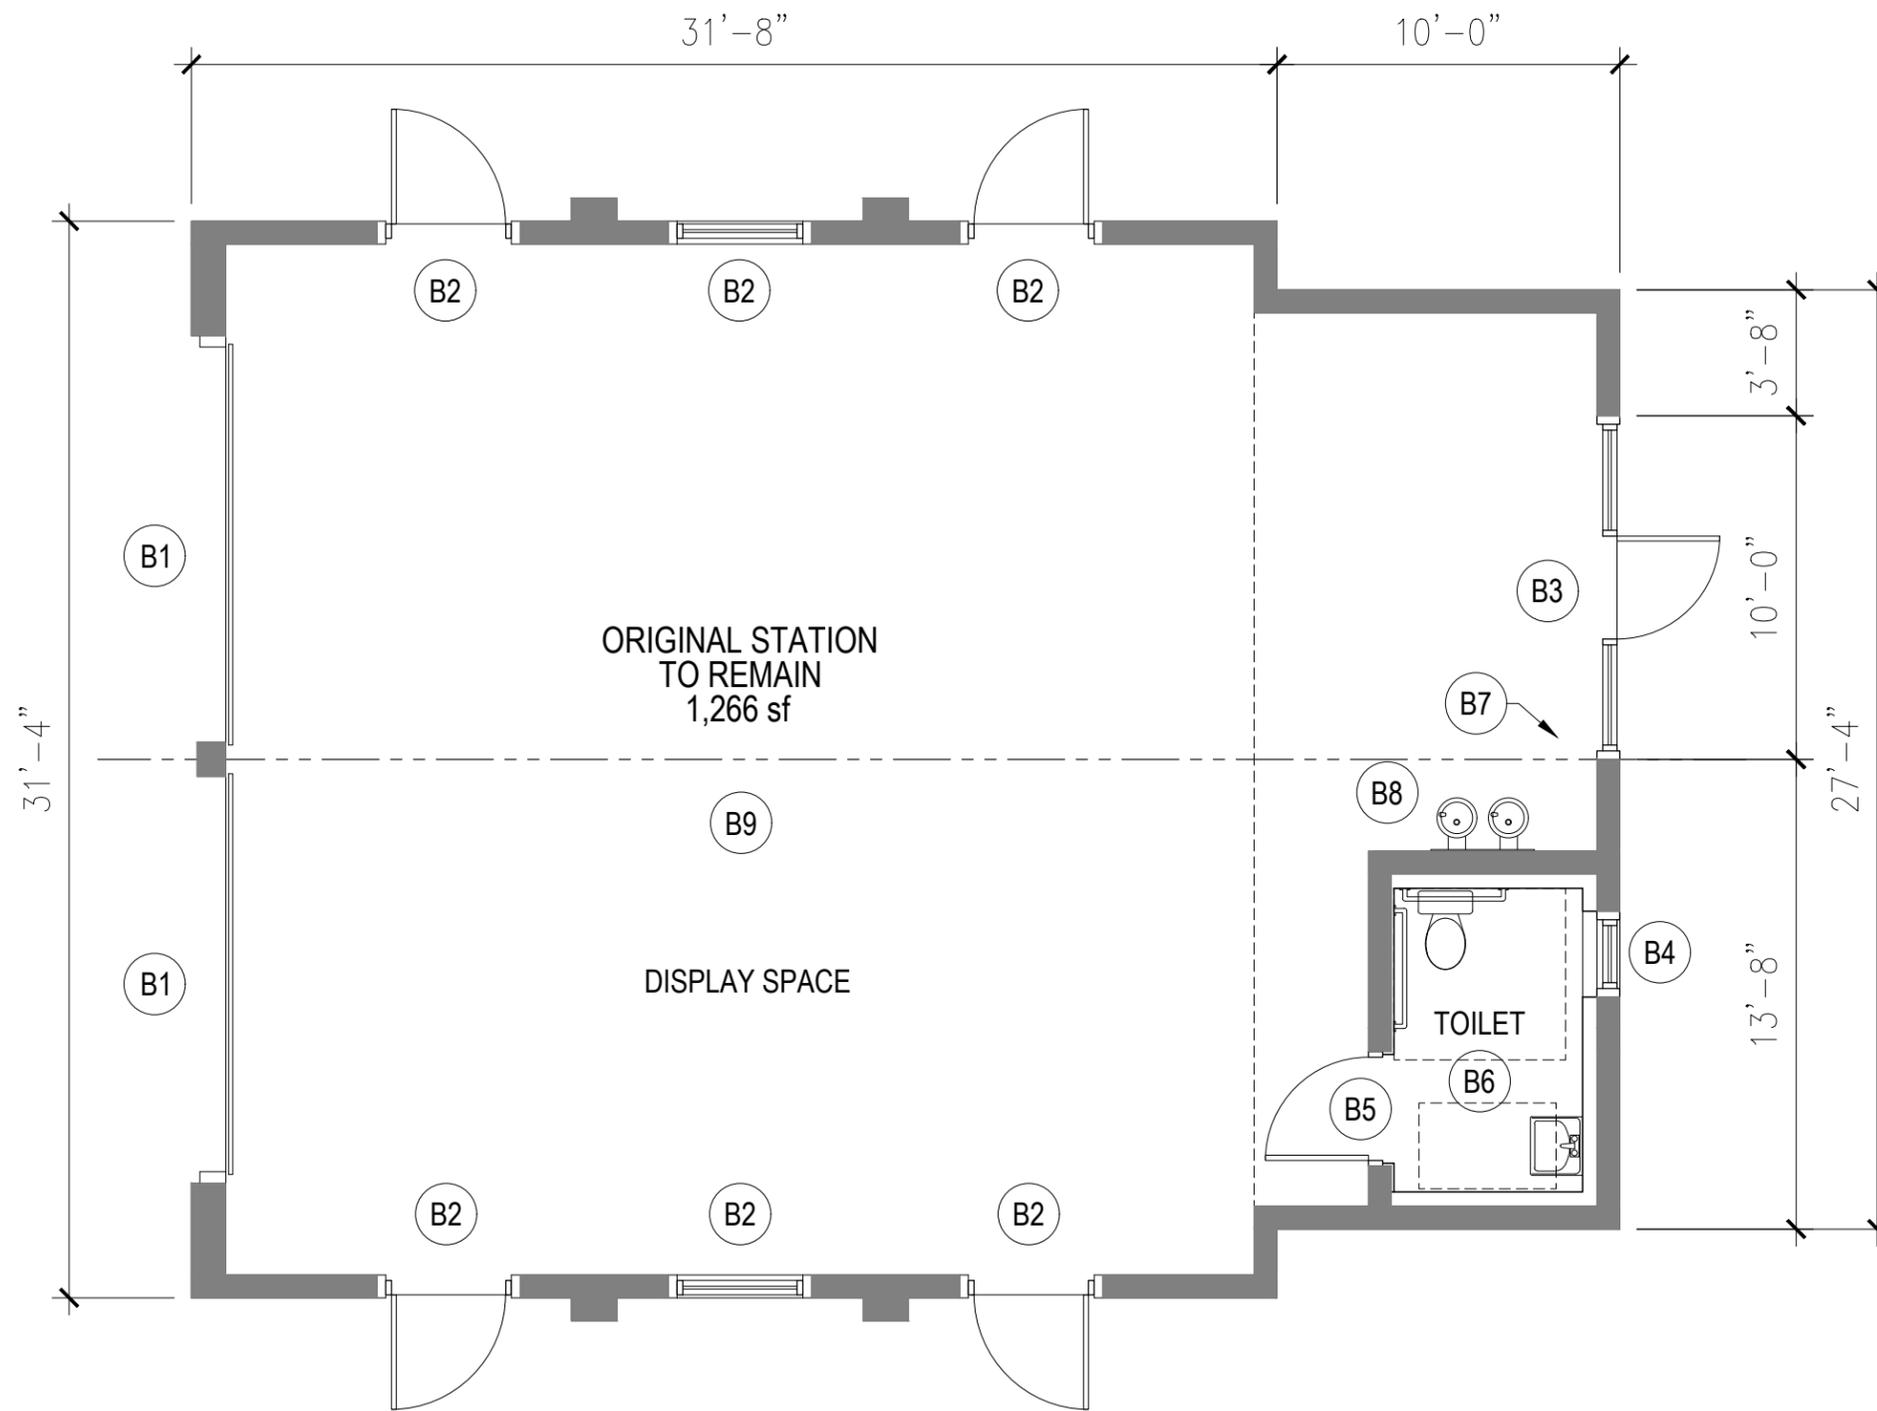
REMODEL PLAN

OPTION 'B' KEY NOTES:

- B1 Repair/paint overhead door frames. Install new aluminum overhead doors with full glass lites. Include motorized operators.
- B2 Replace window and door frames to match historic style. Paint. Install new infill aluminum-clad windows with insulative clear glazing, and aluminum-clad full glass-lite doors with glass transoms where shown. Doors to include closers.

- B3 Install wood surround with aluminum-clad storefront with full-lite door in widened exterior opening.
- B4 Install wood window frame with infill aluminum-clad window with frosted glass at Toilet Room.

- B5 Cut opening wider in existing masonry wall for installation of Toilet Room door. Install painted hollow metal door and frame, with closer.
- B6 For Toilet Room, install furred-out walls with insulation on exterior walls. Wall finish to be ceramic tile full height all walls. Install toilet fixtures, grab bars, toilet accessories. Repair ceiling joists and install new drywall ceiling. Provide access panel to attic space.

- B7 Patch access opening in lower ceiling, patch with wood plank to match adjacent.
- B8 Install new hi/lo drinking fountain.
- B9 Clean and refurbish interior finishes, including floor slab, brick/glazed tile walls, and wood ceilings.

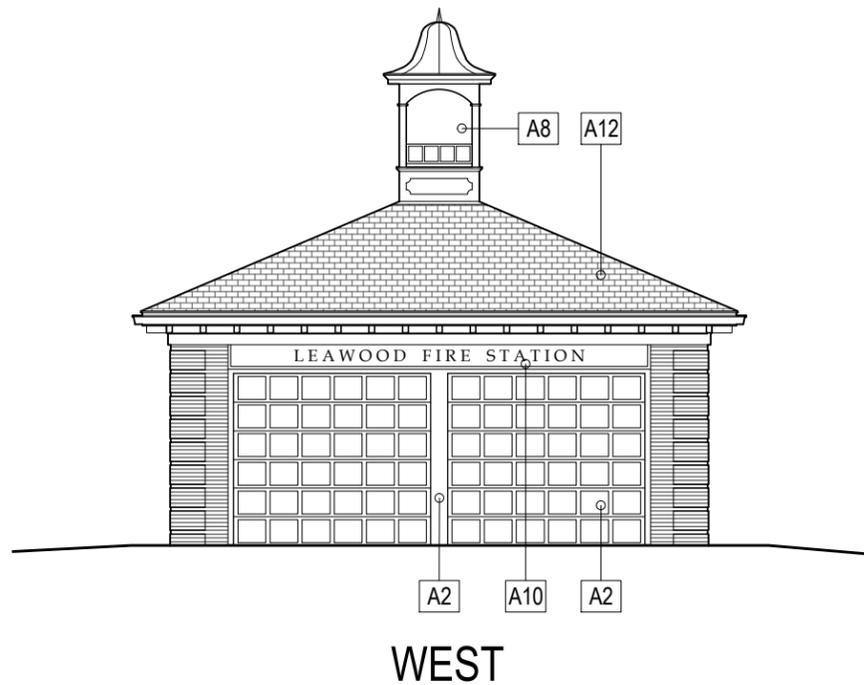
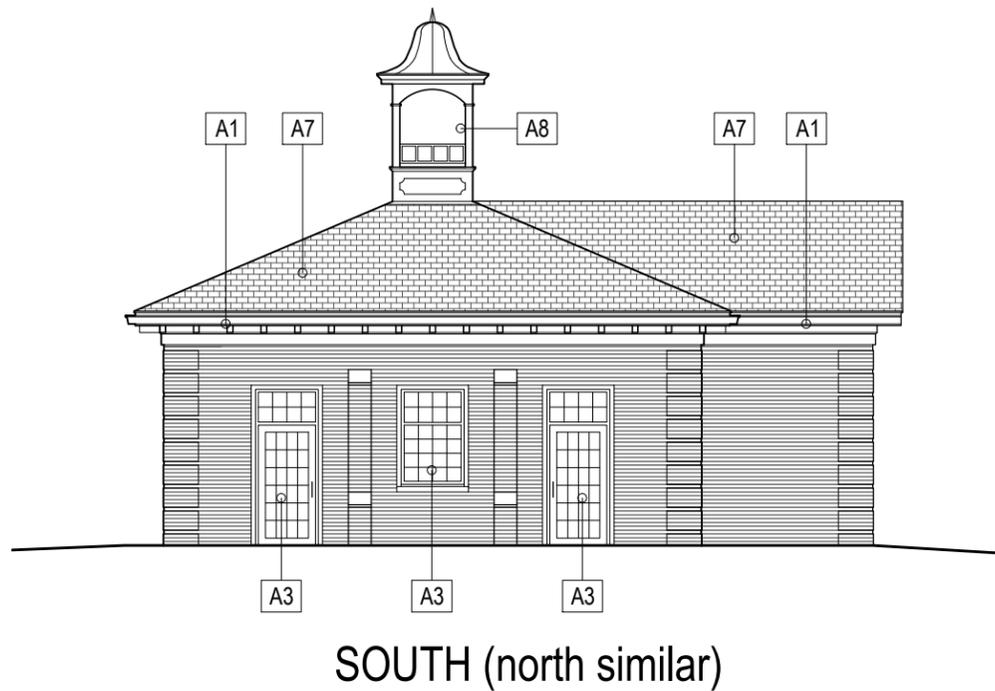
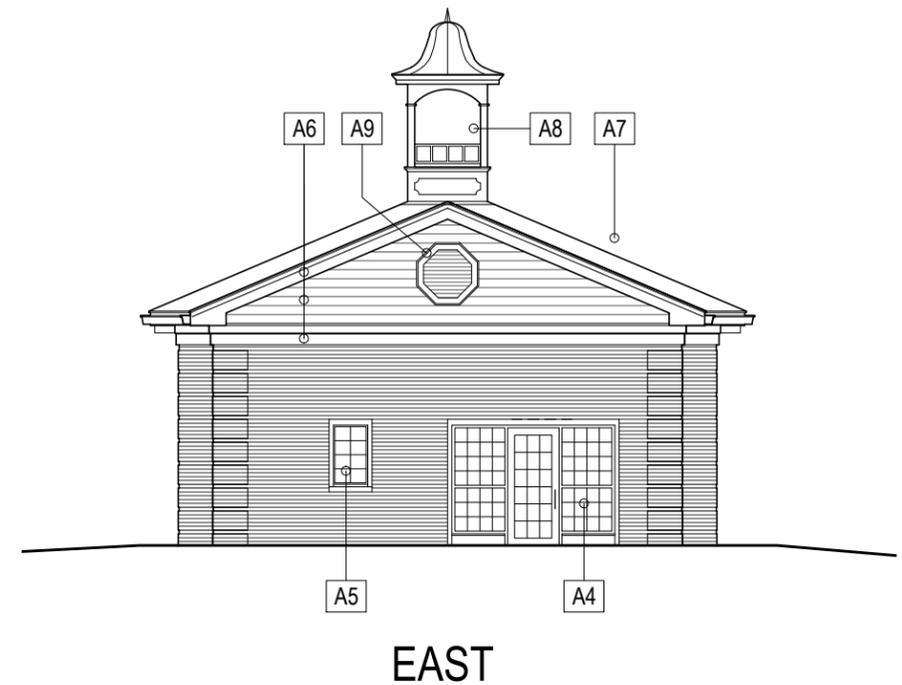
ELEVATIONS AT ORIGINAL BUILDING
October 4, 2108

ELEVATION KEY NOTES:

- A1 Rebuild roof fascias and soffits on north and south, with dentils and detailing to match existing west side.
- A2 Repair wood trim at overhead door openings, painted. Install new aluminum OH doors with full glass lites. Provide motorized operators.

- A3 Repair or install new wood trim/jambes at door and window openings, and install new aluminum-clad windows and doors as shown.
- A4 Cut new widened masonry opening on east. Provide new steel lintel. Install new painted wood trim. Install aluminum-clad storefront system.

- A5 Install new aluminum-clad window and jamb trim at opening in new toilet room (with frost glass).
- A6 Install new wood cornice mouldings and painted 'hardie board' lap siding in newly exposed pediment area of end gable. Repair existing substrate of gable and infill existing openings for new siding. Install eave overhangs.

- A7 Install new synthetic slate-tile look roof shingles, on new ice/water shield barrier. Assume patch and repair of existing wood decking.
- A8 Refurbish cupola; repairs and paint. Remove 'siren' component.

- A9 Install octagonal attic vent.
- A10 Repair or replace signage.

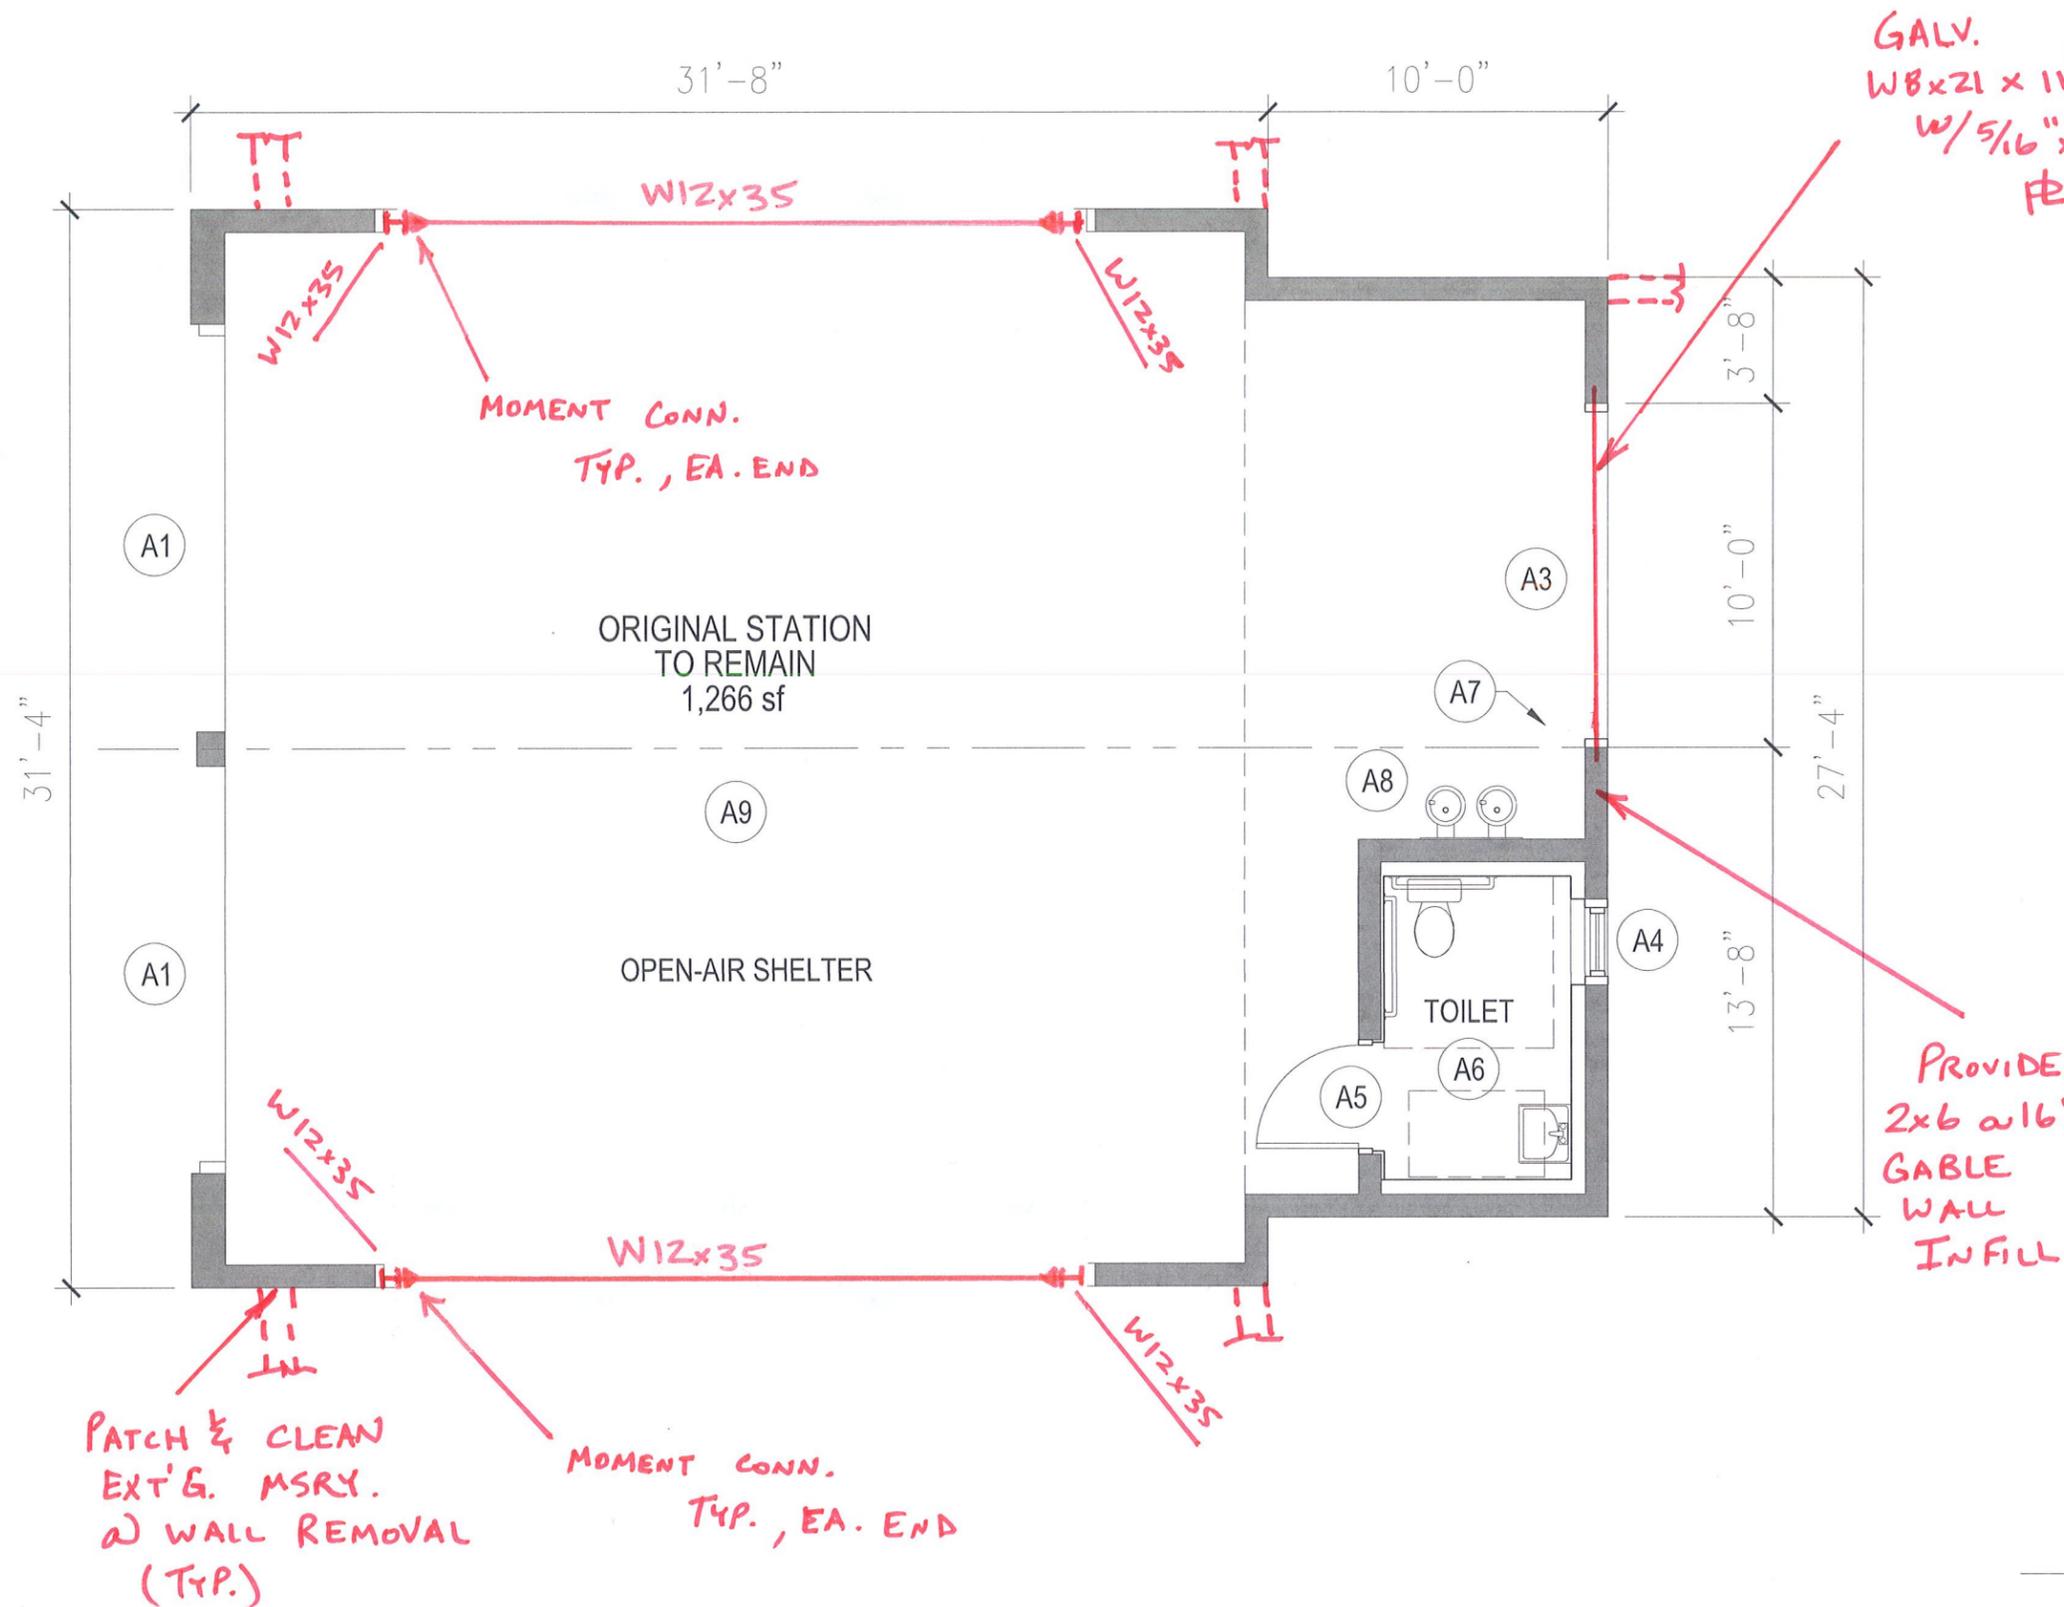
REMODEL PLAN
September 28, 2108

OPTION 'A' KEY NOTES:

- A1 Repair/paint overhead door frames. No doors provided, to remain open.
- A2 Replace window and door frames to match historic style. Paint. (Infill windows or doors NOT provided, to remain open).

- A3 Install wood frame surround to match historic profile in widened exterior opening. (no infill).
- A4 Install wood window frame with infill aluminum clad window with frosted glass at Toilet Room.

- A5 Cut opening wider in existing masonry wall for installation of Toilet Room door. Install painted hollow metal door and frame, with closer.
- A6 For Toilet Room, install furred out walls with insulation on exterior walls. Wall finish to be ceramic tile full height all walls. Install toilet fixtures, grab bars, toilet accessories. Repair ceiling joists and install new drywall ceiling. Provide access panel to attic space.

- A7 Patch access opening in lower ceiling, patch with wood plank to match adjacent.
- A8 Install new hi/lo drinking fountain.
- A9 Clean and refurbish interior finishes, including floor slab, brick/glazed tile walls, and wood ceilings.

Per your request, we have completed our review of the Historic Leawood Fire Station. Our review is based on removal of all additions to this structure restoring the building to its original construction. In summary, we feel the original structure is in sound condition and minimal structural work is required to restore the integrity of the structure to its original condition. We have enclosed the required structural scope for options "A" & "B". At option "A", we have added portal frames at the north and south exterior walls to account for wall removal between existing windows.

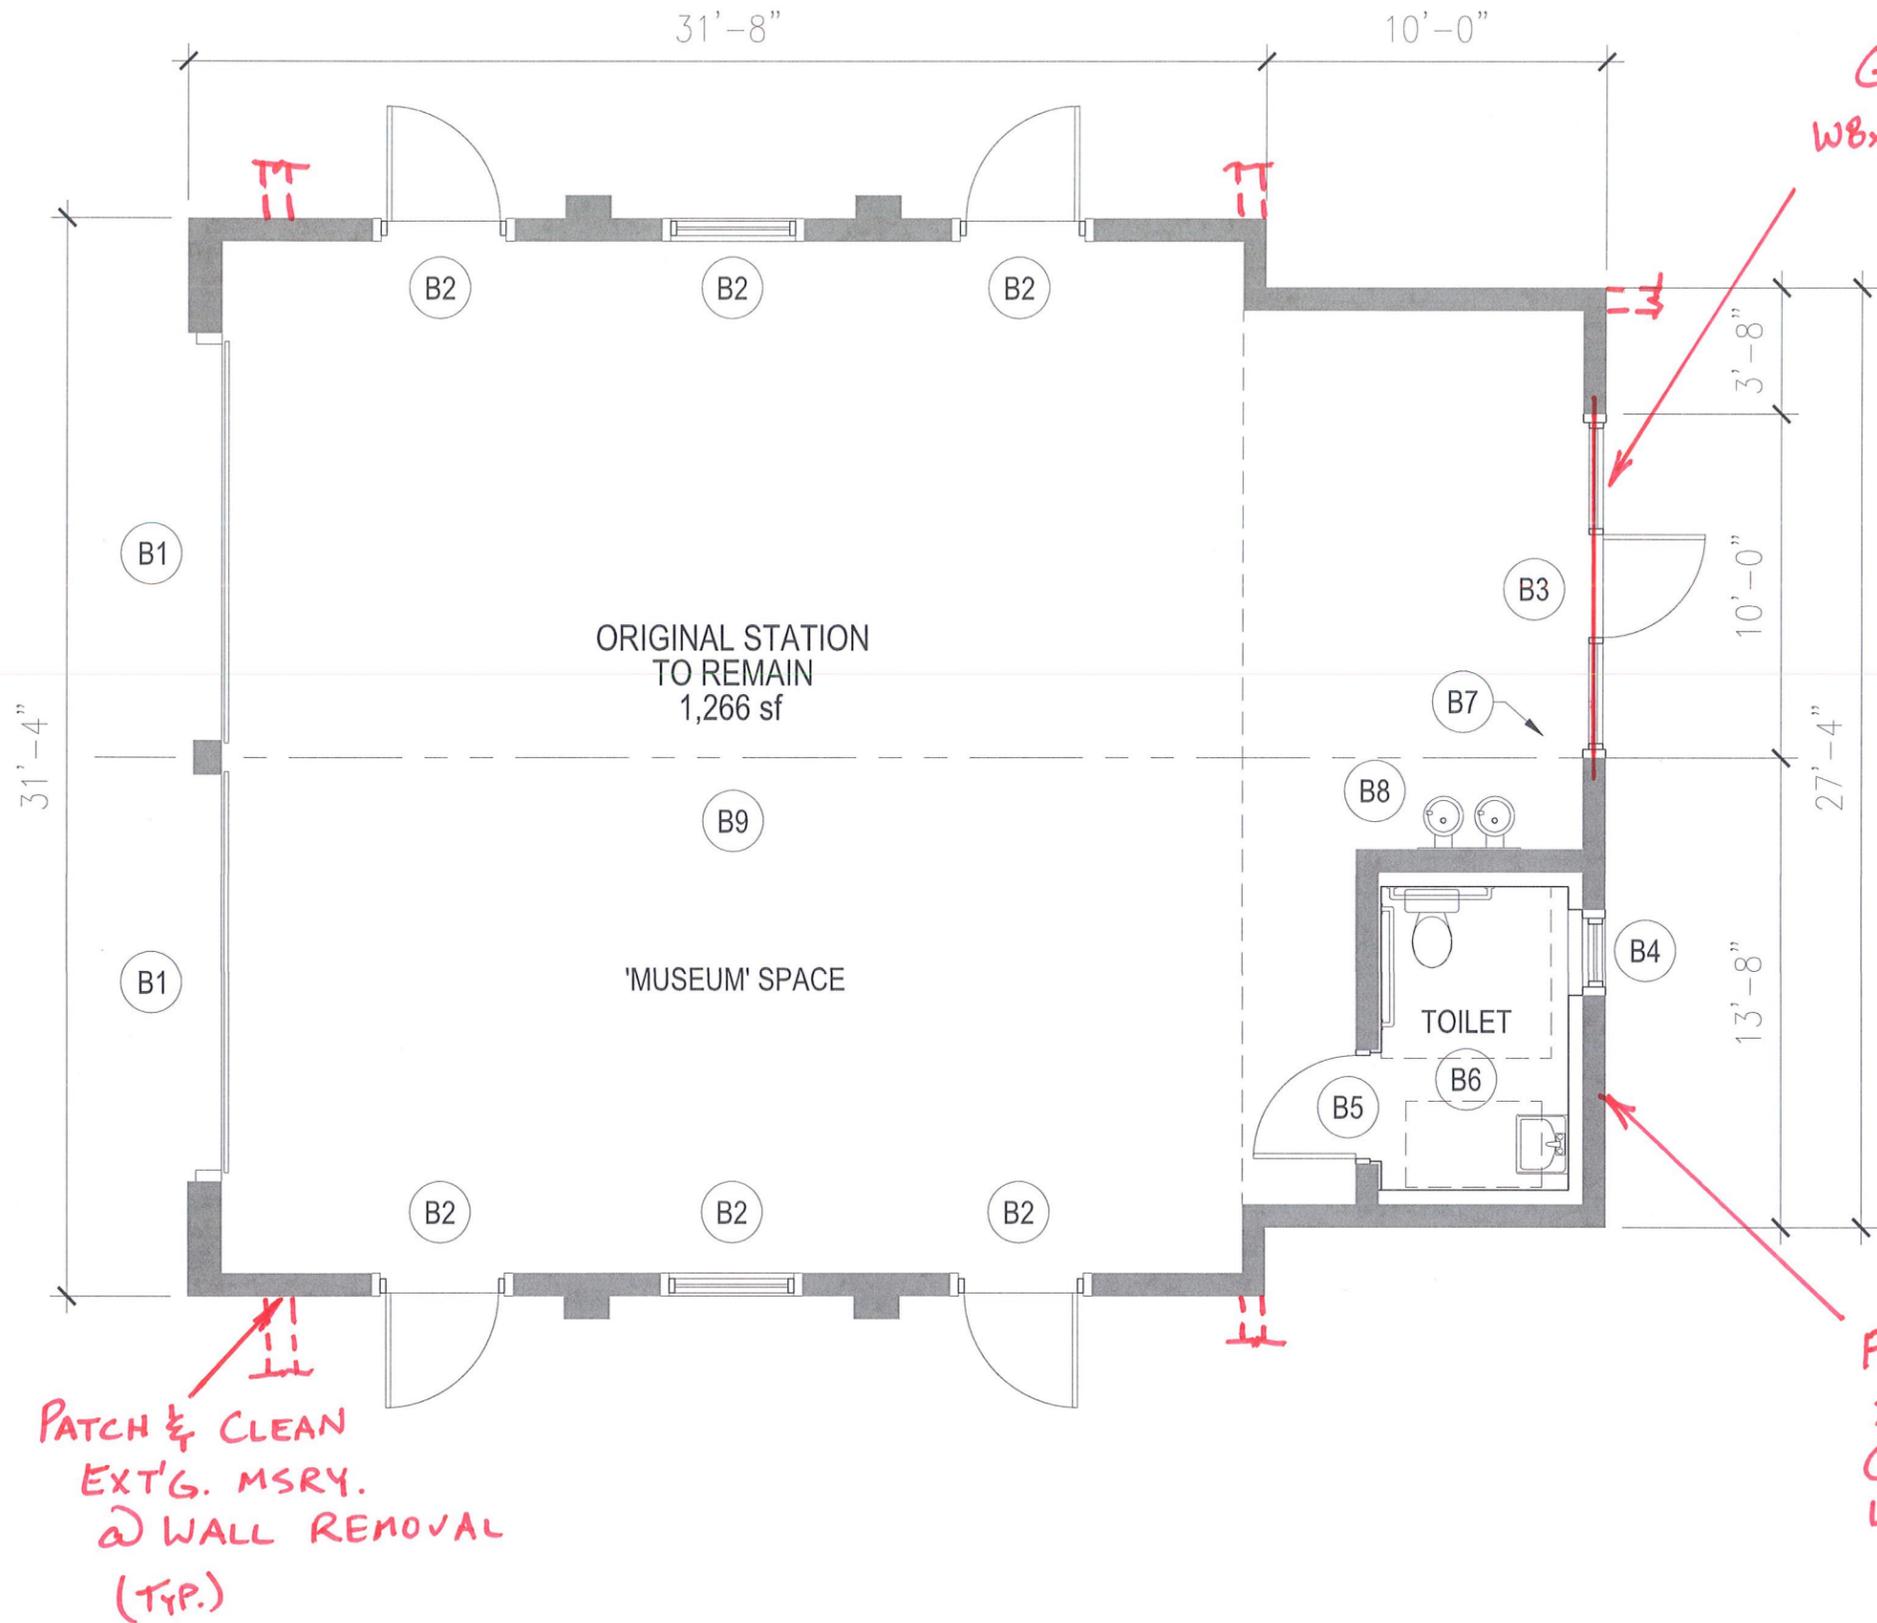
REMODEL PLAN
September 28, 2108

OPTION 'B' KEY NOTES:

- B1 Repair/paint overhead door frames. Install new aluminum overhead doors with full glass lites. Include motorized operators.
- B2 Replace window and door frames to match historic style. Paint. Install new infill aluminum-clad windows with insulative clear glazing, and aluminum-clad full glass-lite doors with glass transoms where shown. Doors to include closers.

- B3 Install wood surround with aluminum-clad storefront with full-lite door in widened exterior opening.
- B4 Install wood window frame with infill aluminum-clad window with frosted glass at Toilet Room.

- B5 Cut opening wider in existing masonry wall for installation of Toilet Room door. Install painted hollow metal door and frame, with closer.
- B6 For Toilet Room, install furred-out walls with insulation on exterior walls. Wall finish to be ceramic tile full height all walls. Install toilet fixtures, grab bars, toilet accessories. Repair ceiling joists and install new drywall ceiling. Provide access panel to attic space.

- B7 Patch access opening in lower ceiling, patch with wood plank to match adjacent.
- B8 Install new hi/lo drinking fountain.
- B9 Clean and refurbish interior finishes, including floor slab, brick/glazed tile walls, and wood ceilings.

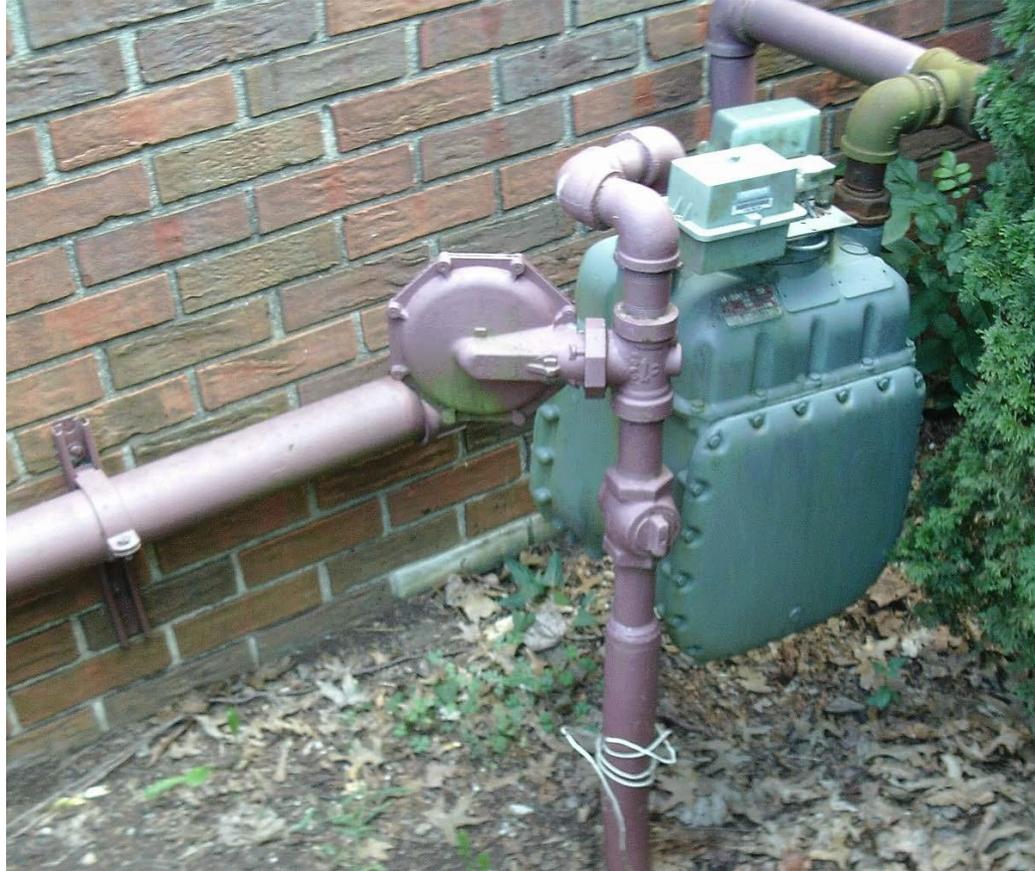
- a. There is an existing gas service that serves the building. It would need to be relocated if only the apparatus bay is to be enclosed, and will need to backfeed new gas appliance to such as water heaters and infrared heaters. If the apparatus bay is left open to the exterior, then the gas service will be removed.
