Re: Fire Station #1 Restoration Study

RESTORATION STUDY
'HISTORIC' FIRE STATION NO. 1
Leawood, Kansas

RESTORATION STUDY 'HISTORIC' FIRE STATION NO. 1

LOCATION: 9609 Lee Boulevard, Leawood, Kansas

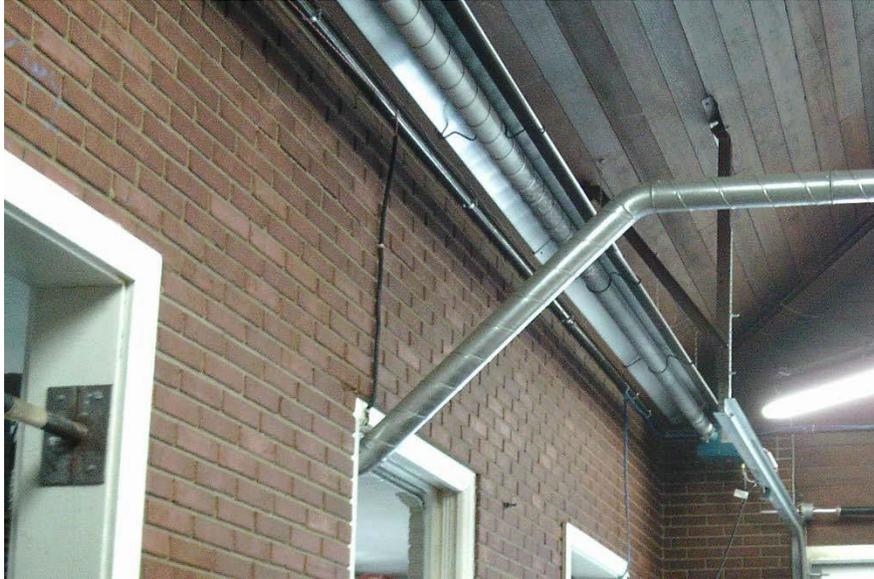
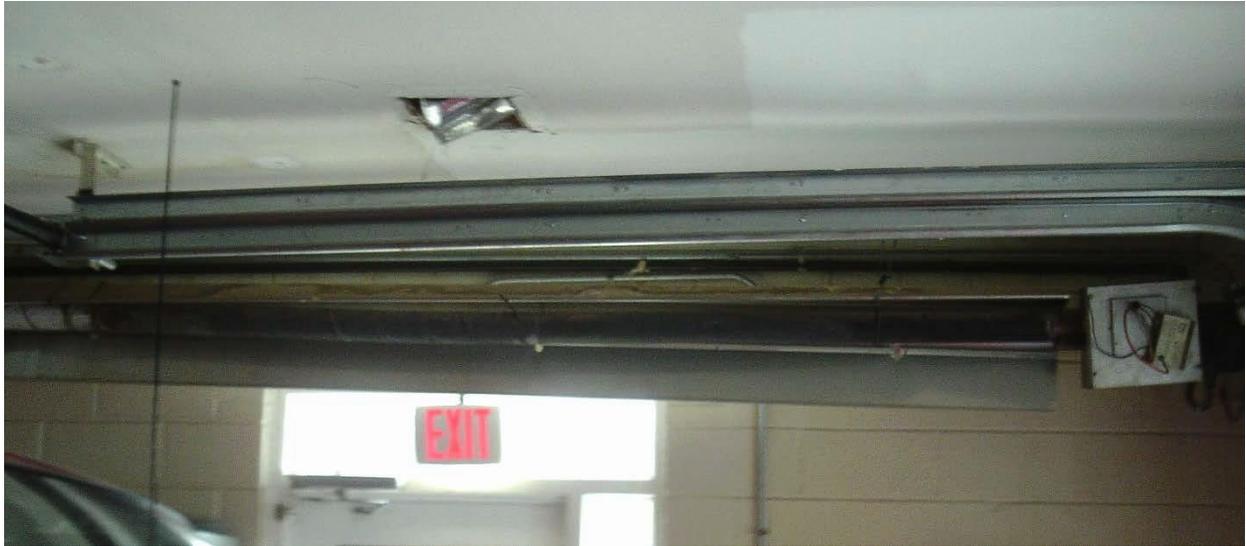
- b. The infrared heaters in the building appeared to be in working condition. But they are nearing the end of their life. It is recommended that all new heat be provided throughout the building if the building is going to be enclosed.

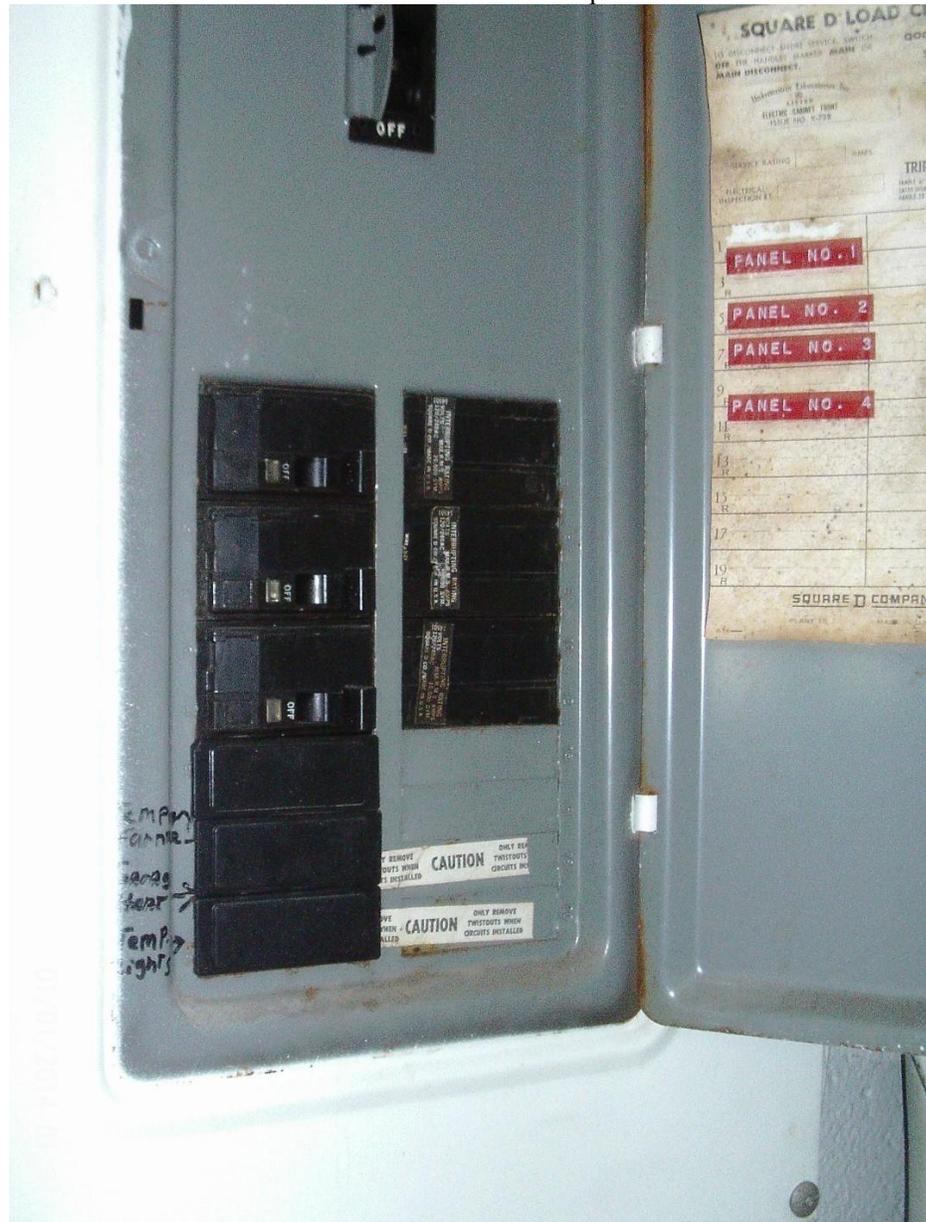
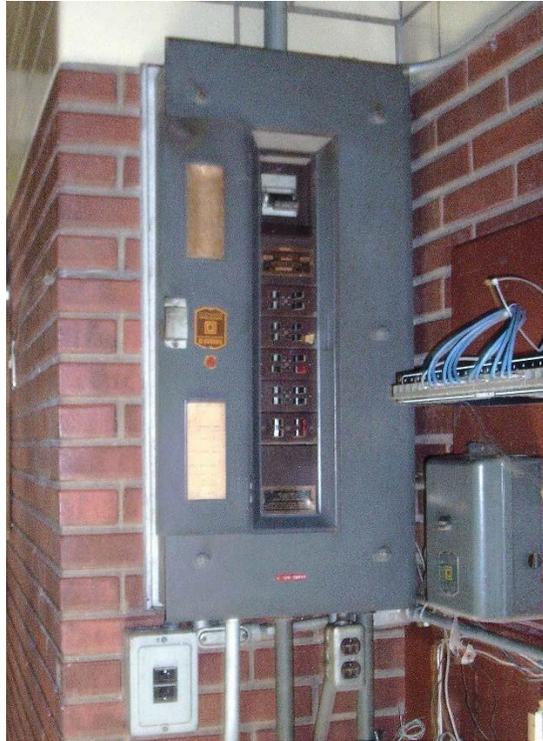
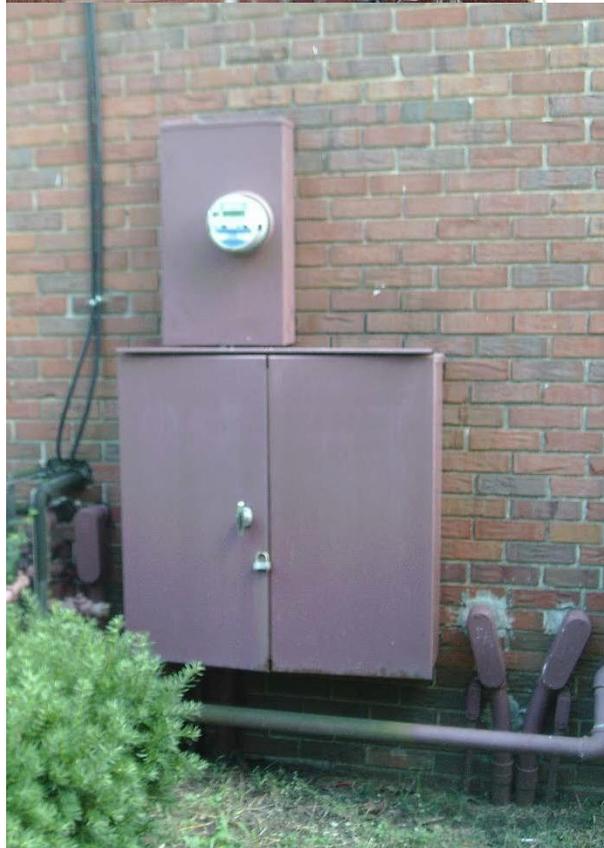
- c. The electrical service is a 120/240 volt, 1-phase electrical service. It has a 200-amp, 18 pole panel that sub-feeds 3 other 100-amp panels (P-1, P-4, and an unnamed panel). The panels are old, but it may be possible to re-use some of the existing electrical equipment. It is recommended that the electrical panels be replaced due to age. It may also be difficult to find replacement breakers. Panel P-4 is an 18-pole panel, the unnamed panel has bad circuit breakers noted. Panel P-1 is very old, and a 20-pole panel. The electrical meter is located on the exterior of the building on the north side of the building. If they are only keeping the main apparatus bay, we would recommend replacing the entire electrical service. Provide a new meter / CT cabinet (if required) near the location where the unnamed panel is currently located and provide a new 100-amp panel where panel P-1 is currently located. It shall be sized to accommodate the load that is to remain. All other panels and emergency equipment would then be removed. Existing circuits that are to remain would be circuited back to the new panel.

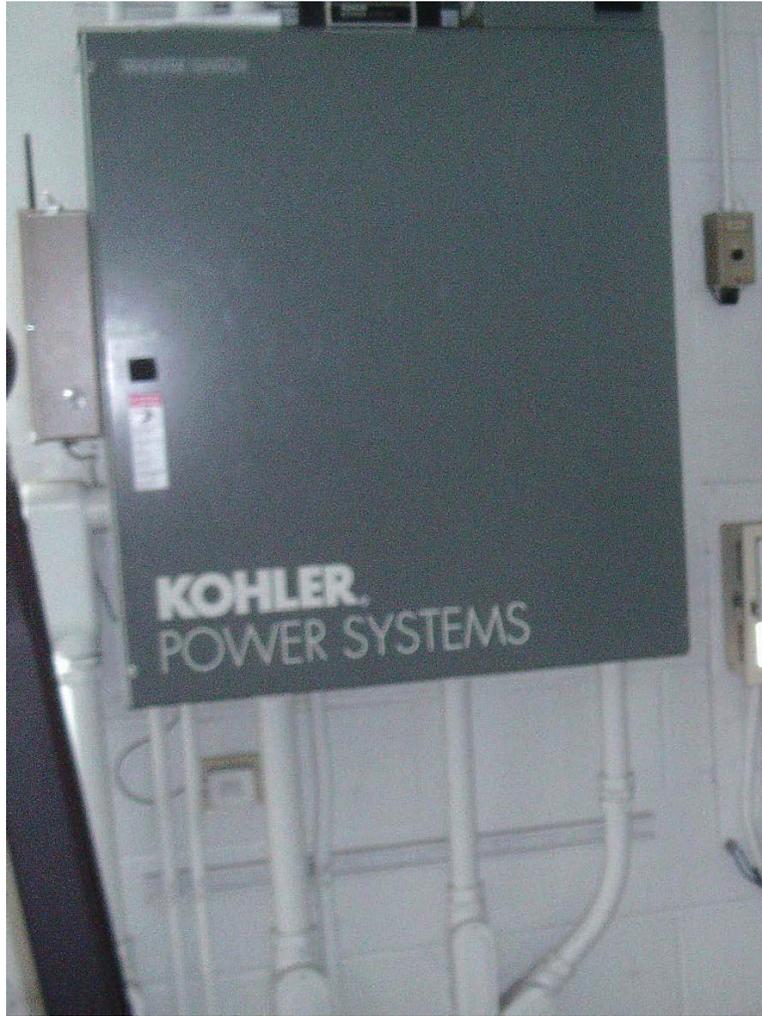
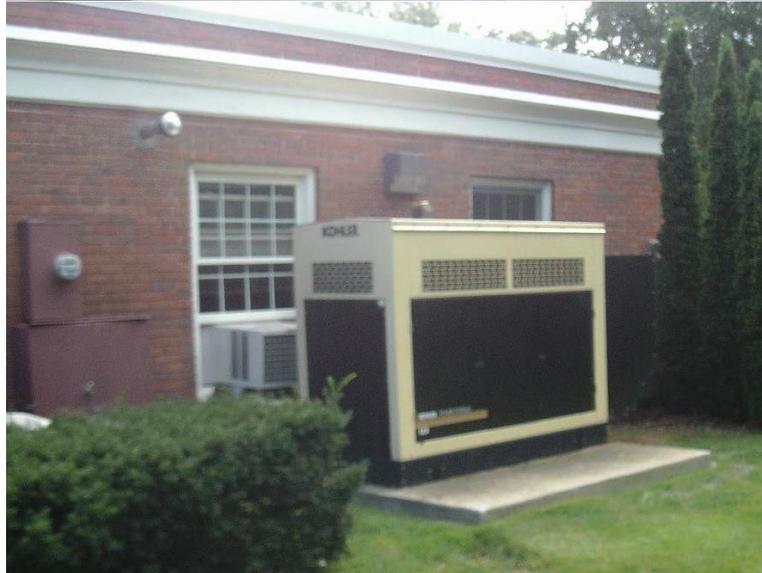
- d. The generator and transfer switch appear to be newer than the rest of the electrical equipment and could be re-used, but are not anticipated being needed for this project. Contractor shall remove and turn over to owner.

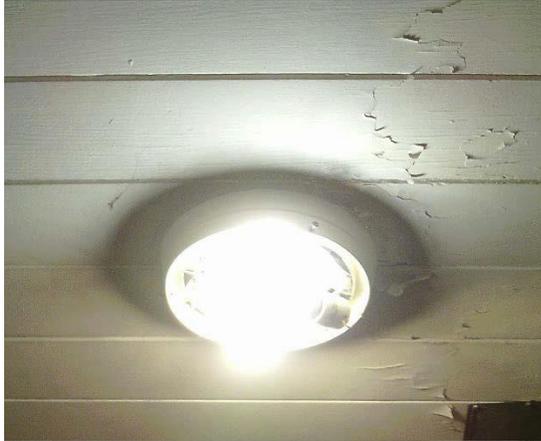
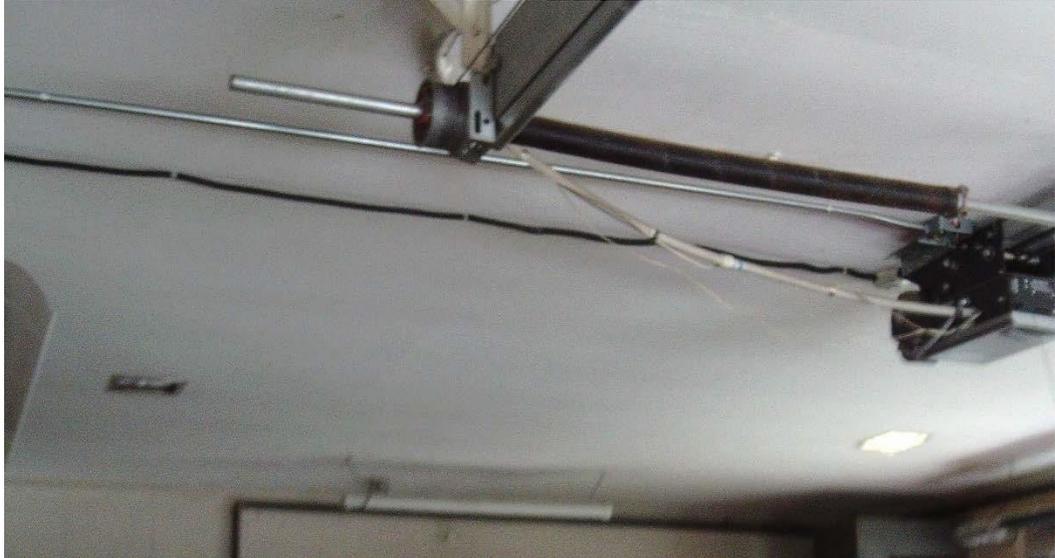
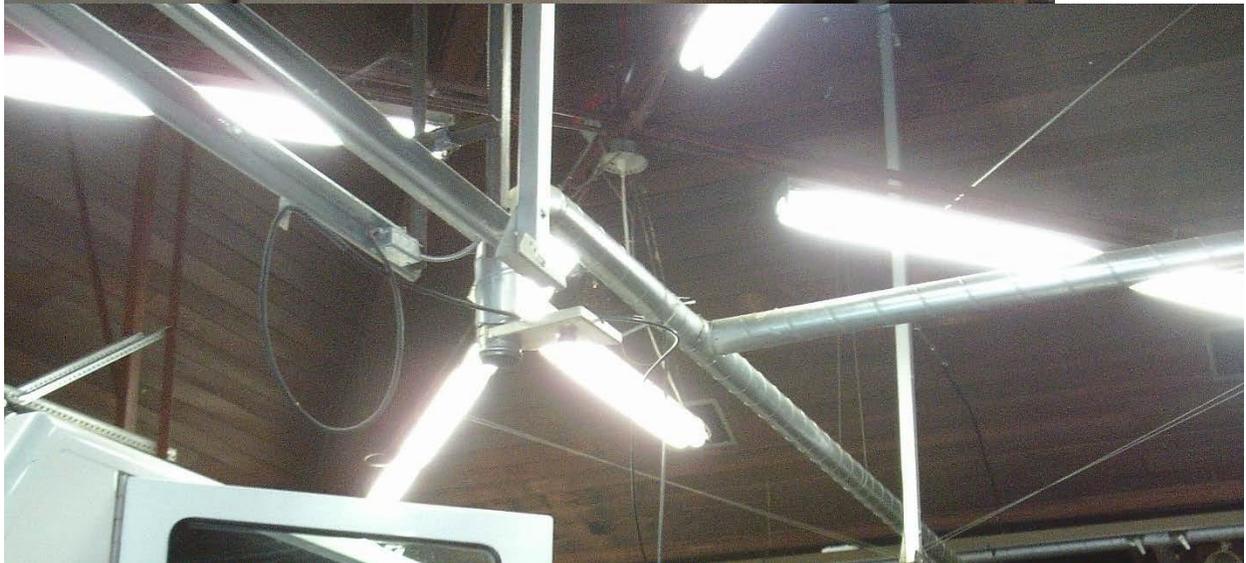
- e. The lighting throughout the facility is very inefficient. The lamps in the fixtures are mostly T-12 fluorescent lamps or incandescent lamps. We would recommend replacing the light fixtures and controls with modern lighting to meet today's energy codes.

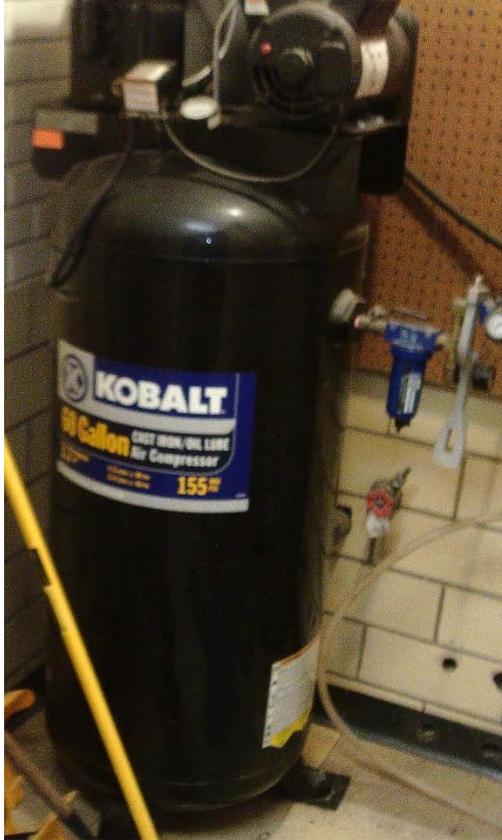
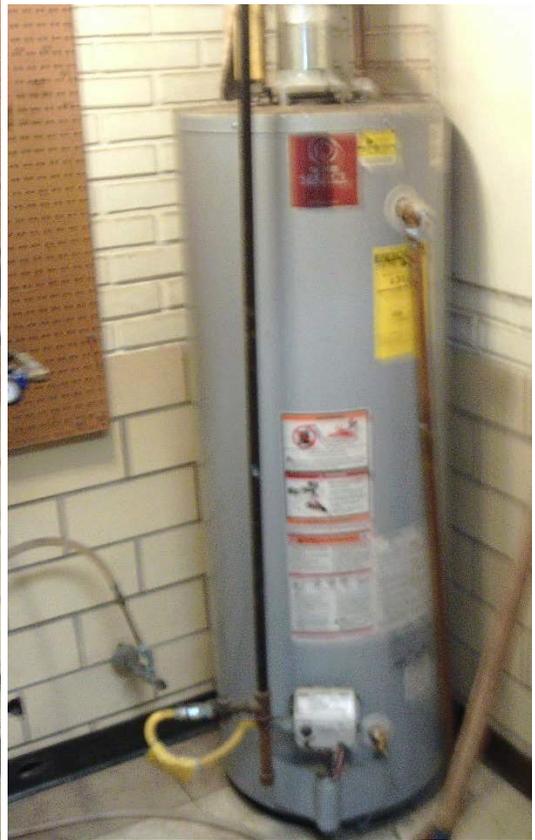
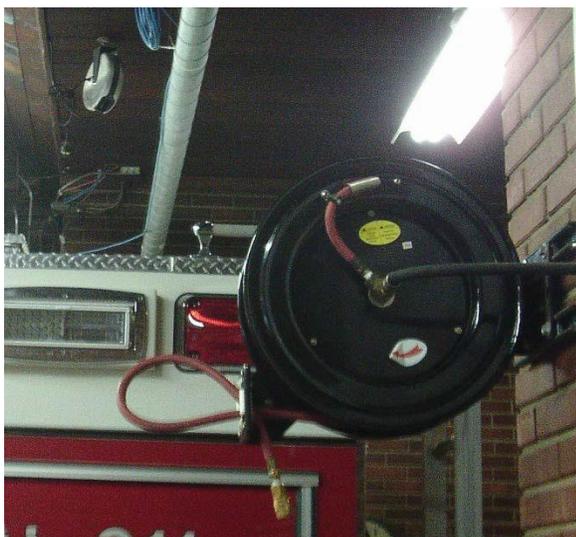
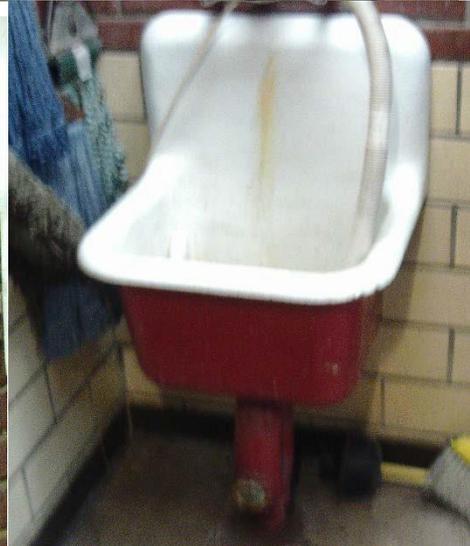
- f. There are a few miscellaneous receptacles located throughout the building that appear to be working. These will be circuited back to the new electrical panel.
- g. The building has domestic water and sewer. However, both of these services would need to be redone if the only thing remaining is the new restroom off the main apparatus bay. The water service will require space for a new backflow preventer.
- h. The janitor's room is equipped with an old cast iron tub type sink, a 50 gallon, 40 MBH water heater and an air compressor. All of this is operational but will be removed since this space is being converted to a restroom.

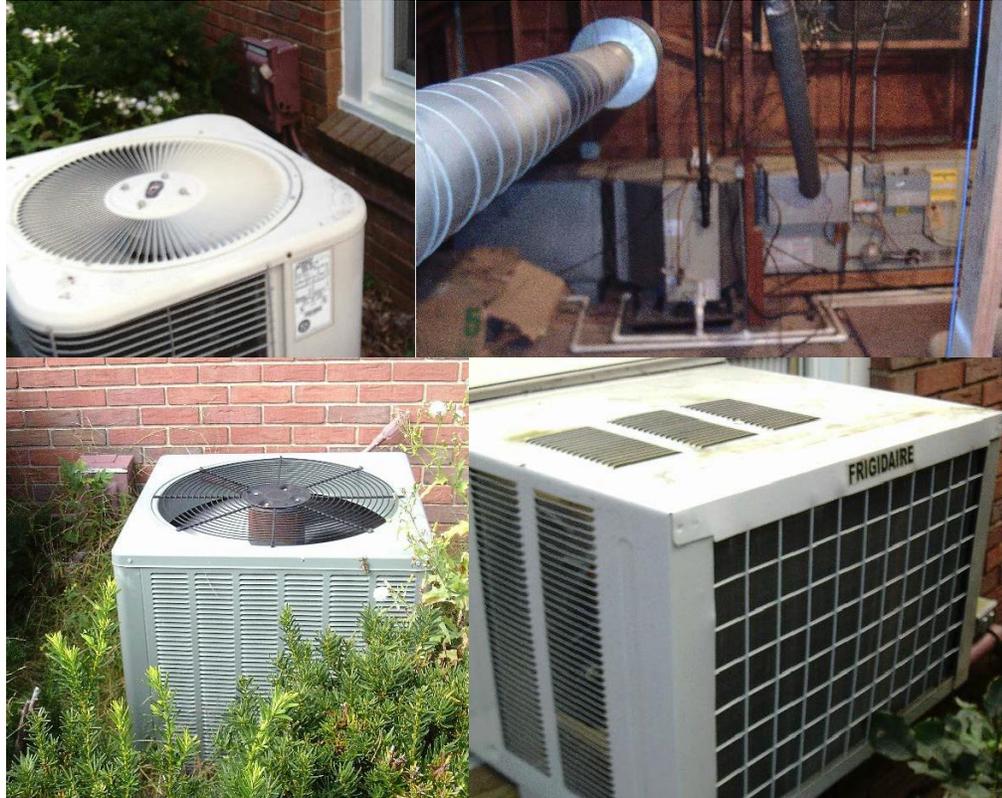
- i. The existing HVAC serving the spaces surrounding the main apparatus bay have reached the end of their expected life. There are three Carrier furnaces from the late 1980s and three Lennox cooling coils located in the mezzanine and condensing units for these are located on the north side of the building and are from 2002. There is a Frigidaire window unit serving the workout room on the northwest corner of the building. There is a Weatherking unit located on the south side of the building with a furnace in a closet inside. This unit is from 2009. These units will all be removed.

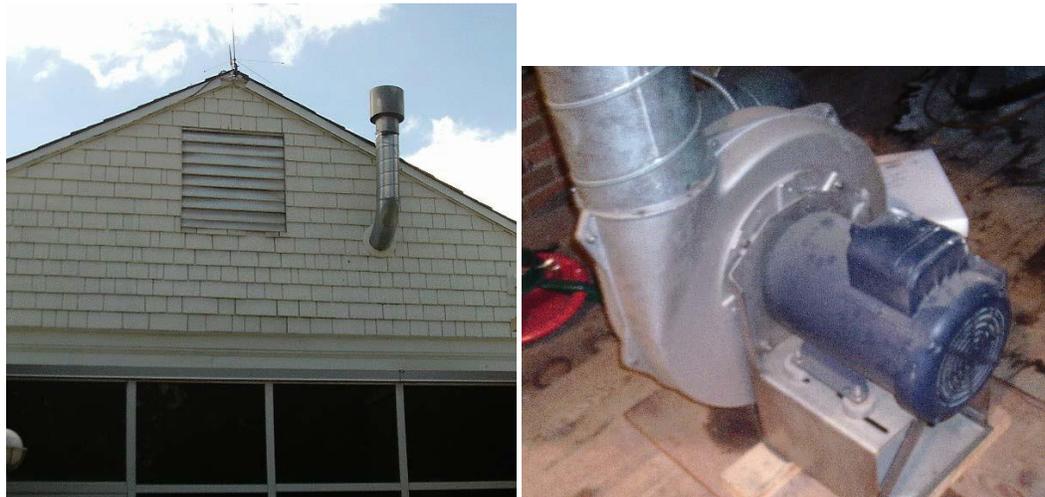
- j. There is an existing vehicle exhaust system in place that is functional. This system will not be used, and will therefore need removed.

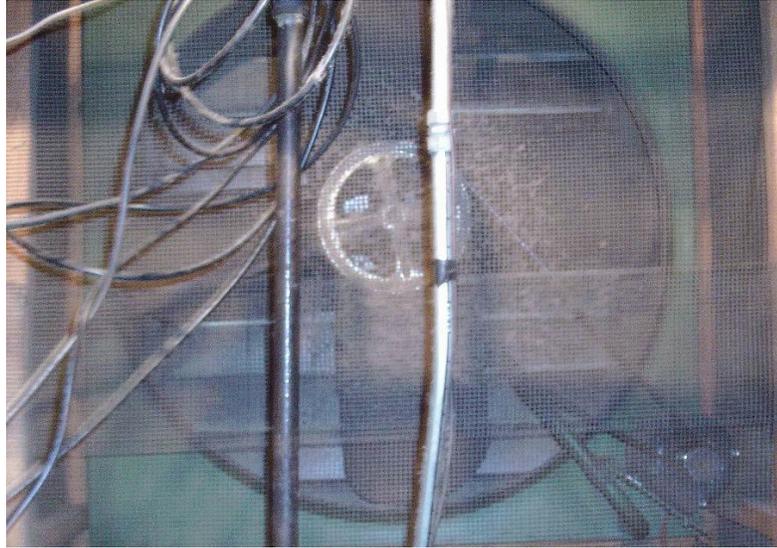
- k. There is a fan for ventilation in the mezzanine space. It appears old, but operational. This system will no longer be needed, and it shall be removed.
